# *M/V Cosco Busan:* Incident Overview & Incident Specific Preparedness Review

Steve Lehmann  
Scientific Support Coordinator, New England  
National Oceanic & Atmospheric Administration

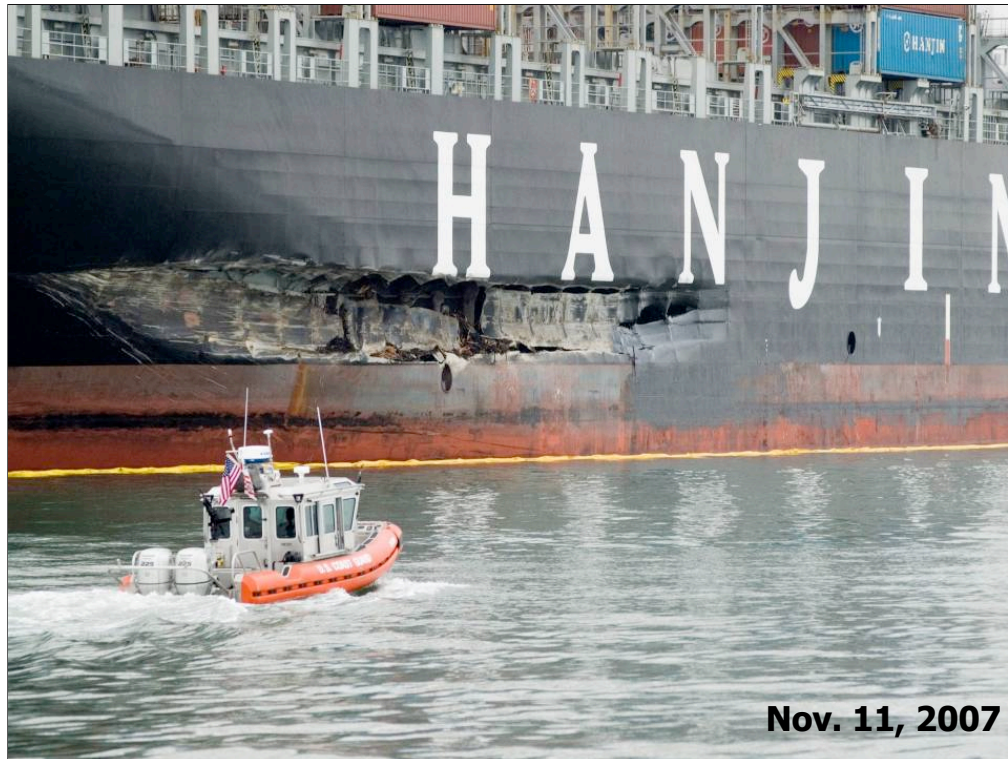
\*This photo was taken on November 11 at Oakland Berth 56. To give a perspective of the size of this gash, the vessel is 900 feet and the gash was 100 feet. Visibility at the time of the incident was 300 feet.

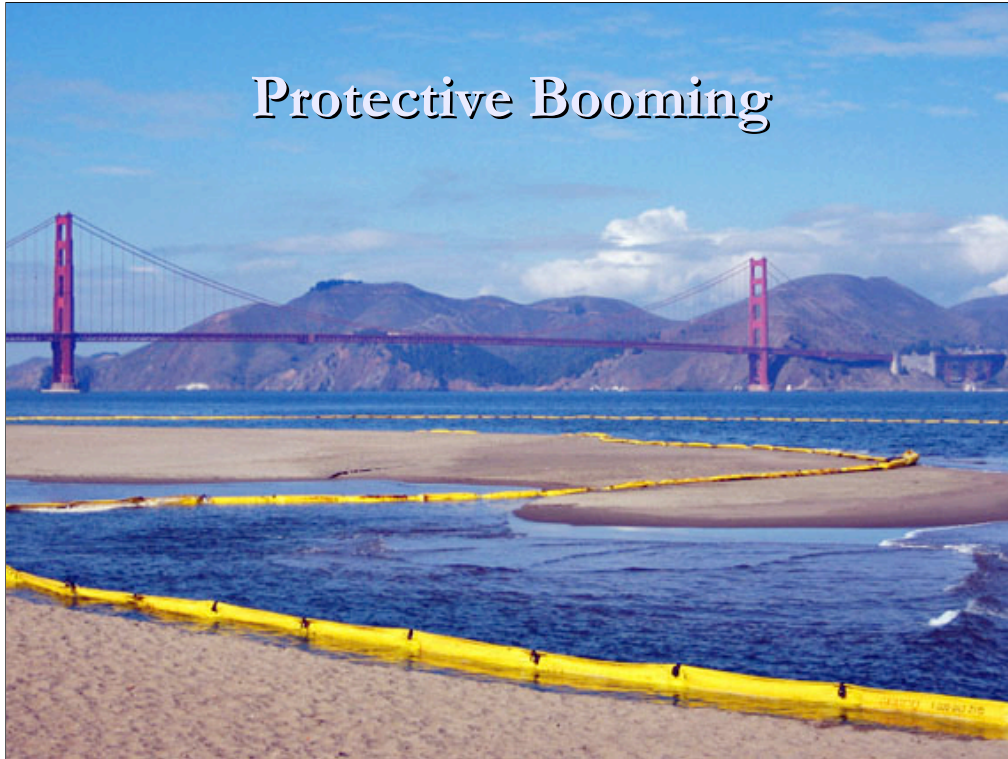
This boom is specifically protecting the restored Crissy Field marsh sensitive site.  
Be prepared to answer questions on boom strategy and boom maintenance.

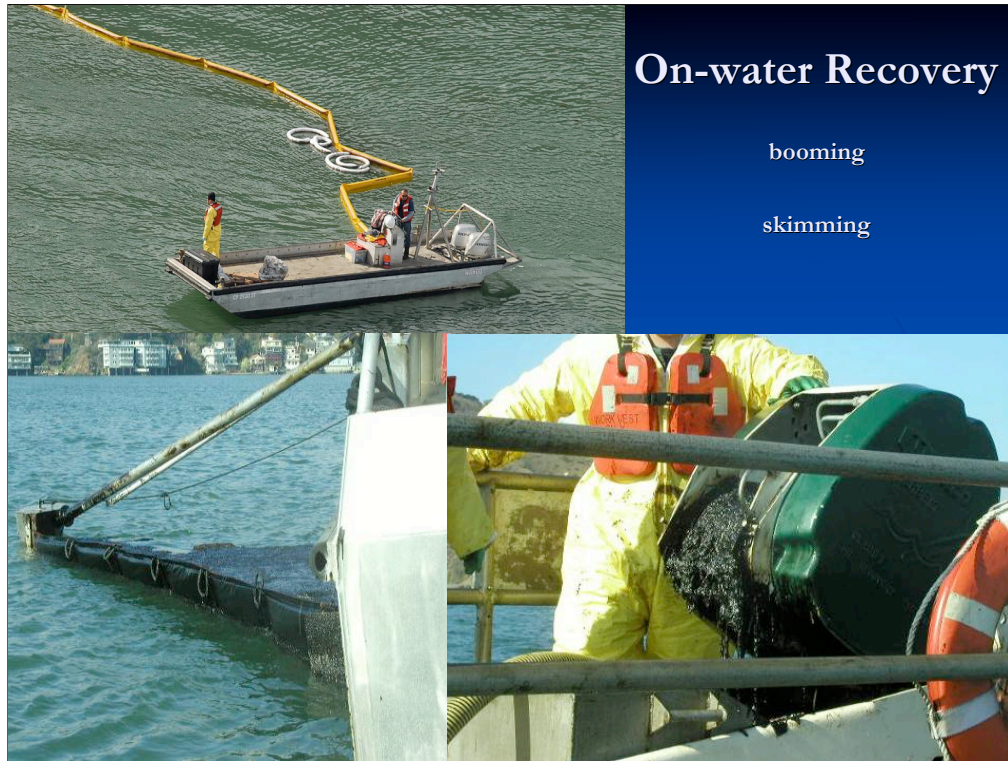
- This is a specialized vessel being used for boom deployment on the north side of Angel Island.
- Note the personal protective equipment and the hard and sorbent boom.

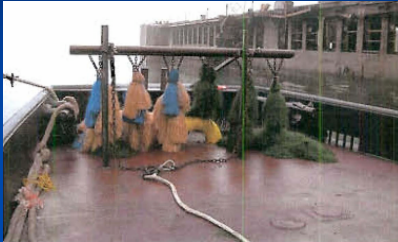
The first photo shows the boat-based pom-poms towed in 3 sites in the East Bay that had moderate to heavy shoreline oiling.

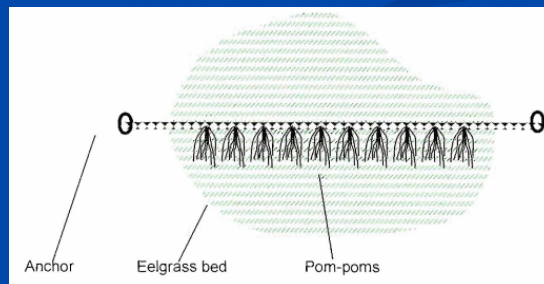
The second photo shows passive-anchored pom-poms in 6 eel grass beds known to be used by herring.

No oil observed on pom-poms in either the passive-anchor method or the boat-based method.

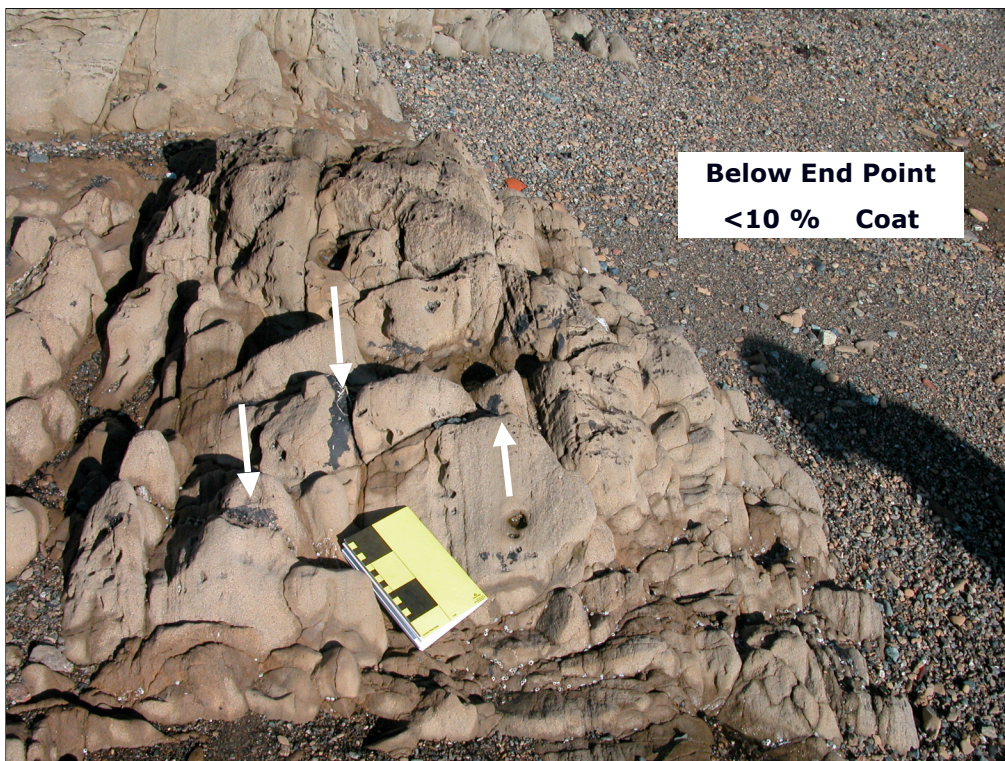
M/V Cosco Busan  
Segment Inspection Report – Phase IV Final Sign Off

Endpoint Criteria / Inspection Team Comments:  
Sutra Baths & Cliff House —  
meets endpoints.  
Traces of Non Cosco & Cosco oil << 1%.

"An NFT with a small amount of oil that was below the end-point criteria"

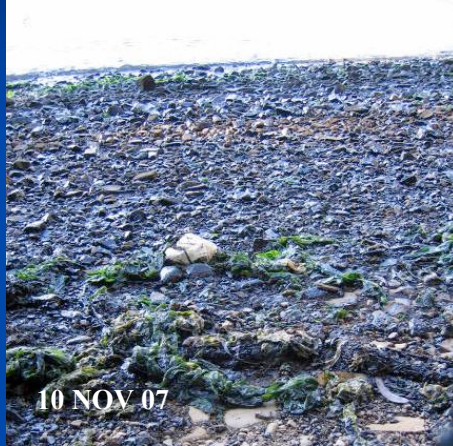
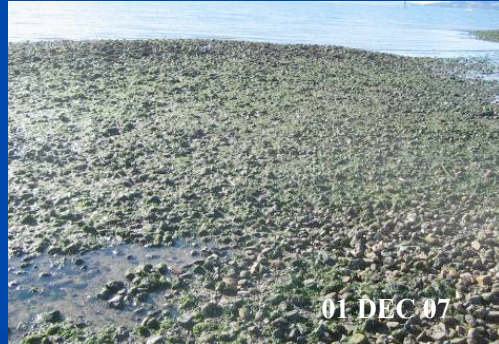
## Marin County

These photos are from the Tiburon Peninsula

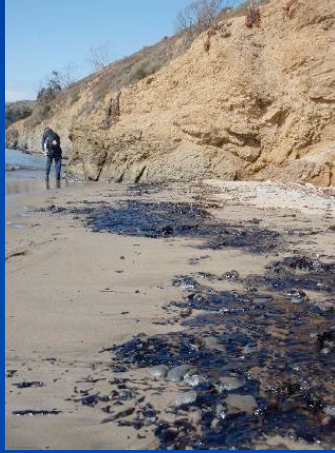
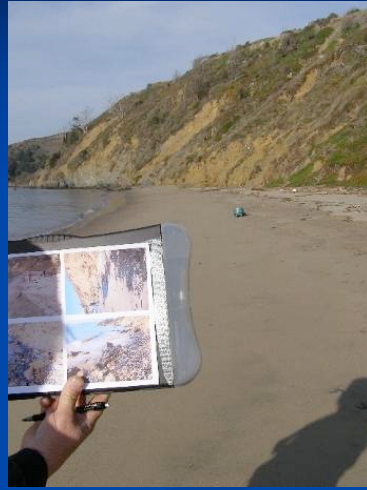
## Angel Island

These are before and after photos of Angel Island.

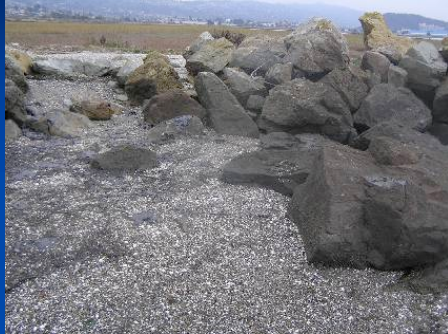
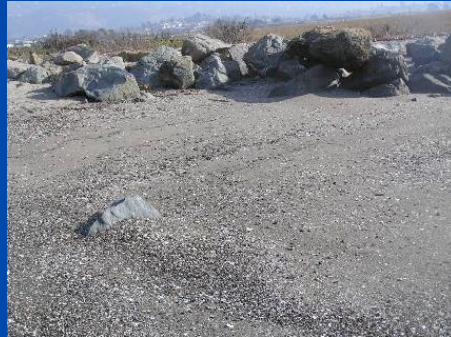
## Contra Costa County

These photos were taken at Shimada Friendship Park in Contra Costa County.
